FRONTIERS OF THE ROMAN EMPIRE

RIPA PANNONICA IN HUNGARY (RPH)

NOMINATION STATEMENT

Vol. 2

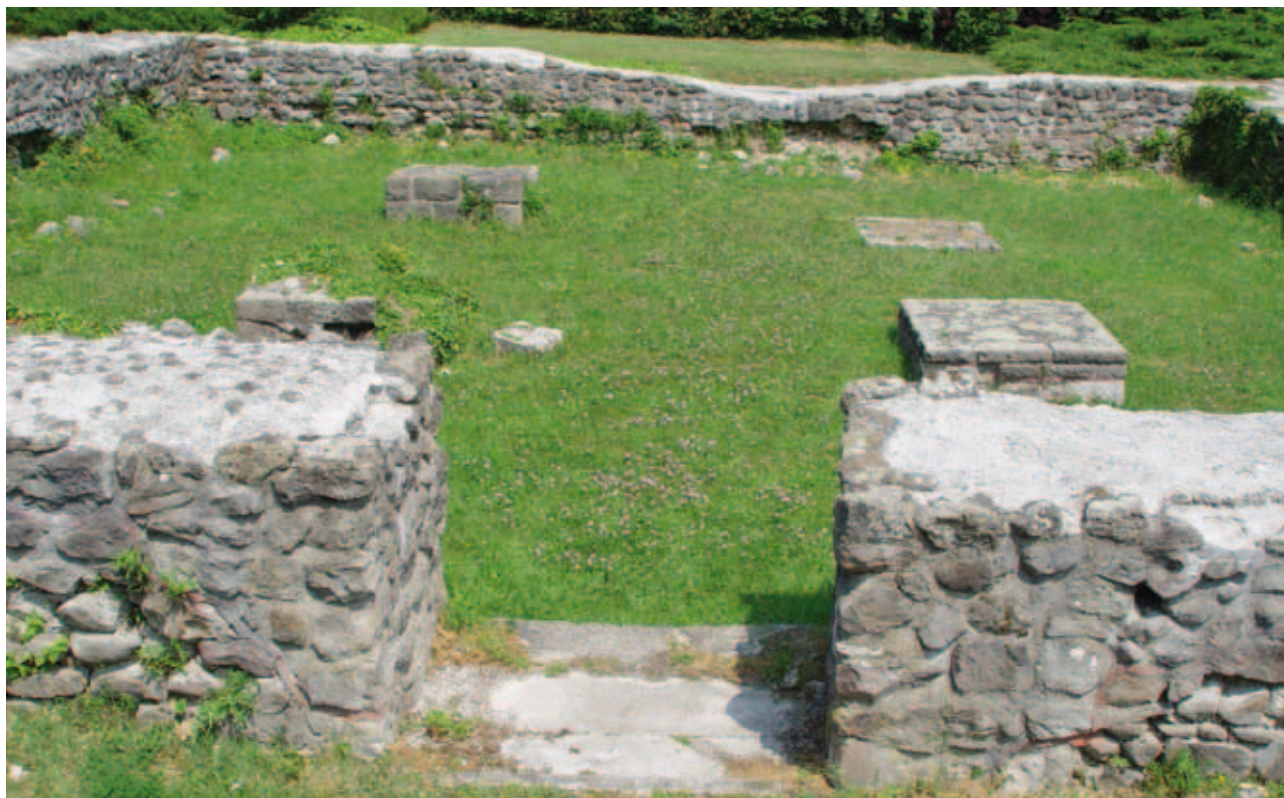
The watch tower from the south. The entrance and the four interior pillars, as well as the deterioration of the condition of the interior of the northern wall can be easily seen. (Photograph: Ferenc Redő)

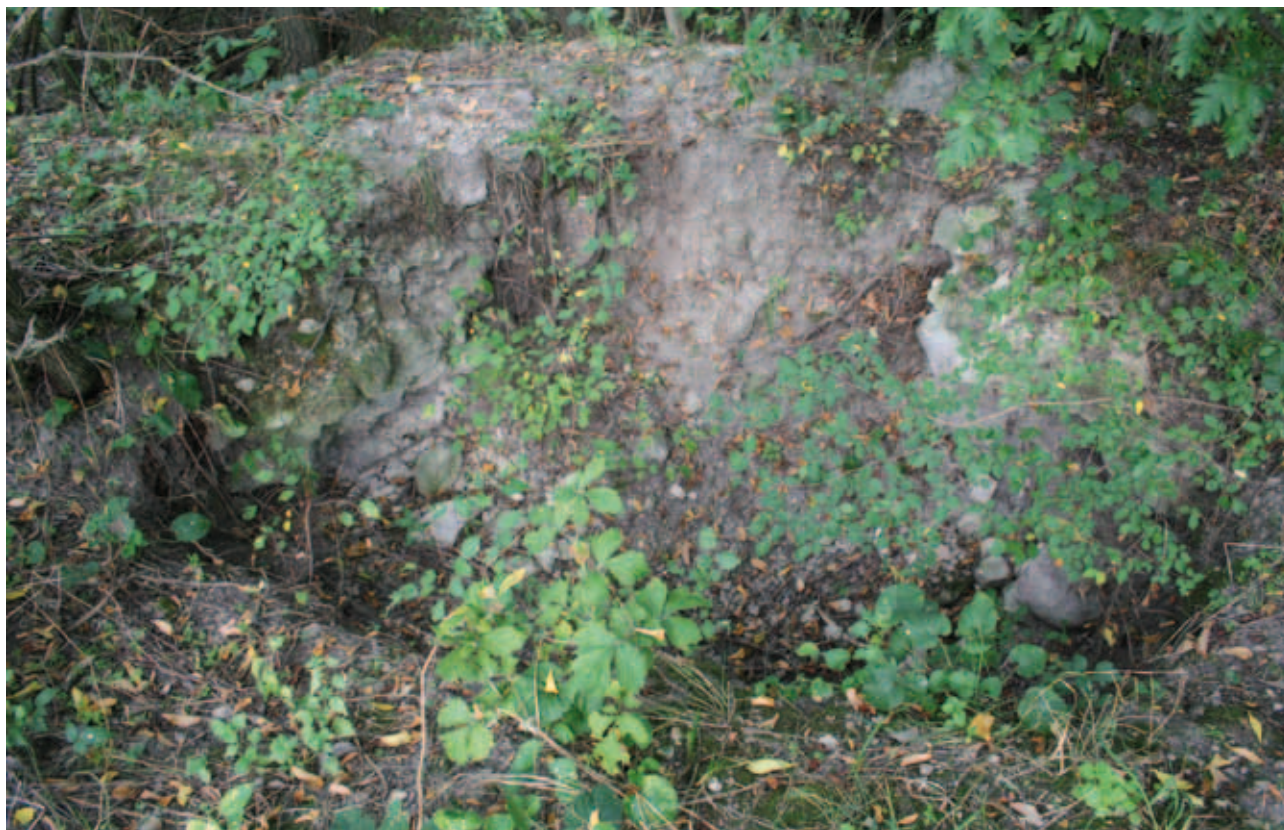
One of the countless holes dug by treasure hunters, who continuously damage the site (Photograph: Dénes Jankovich-Bésán)

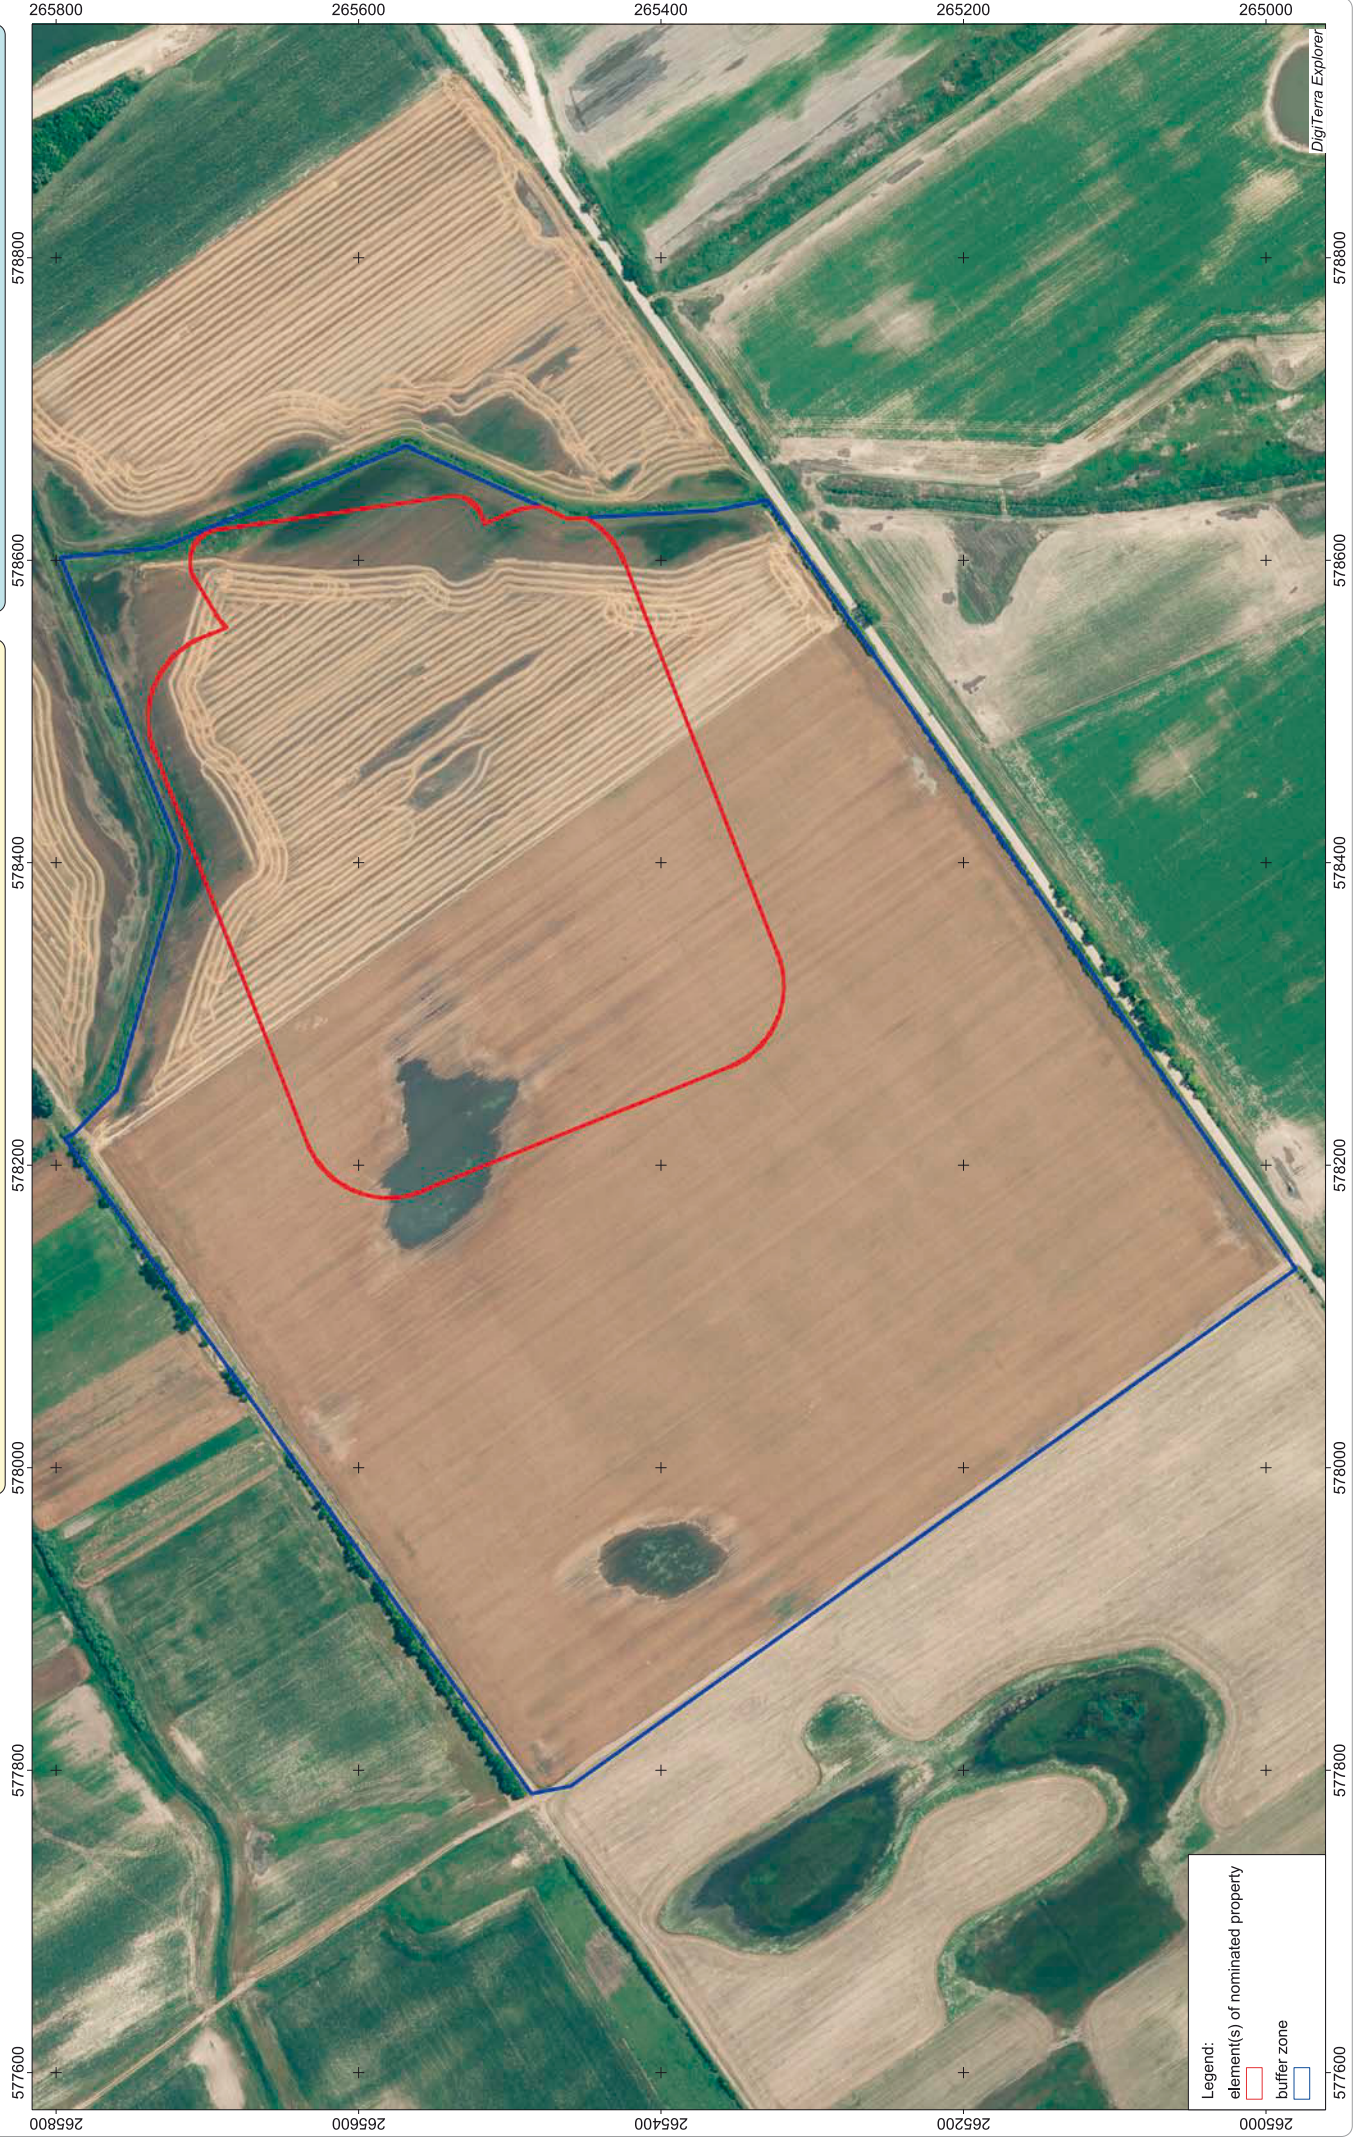
RPH 87. Brigetio – XXX–XXXI camps,
Komárom

Ground plan of Brigetio – XXXI camp (Digitalization: PTE)

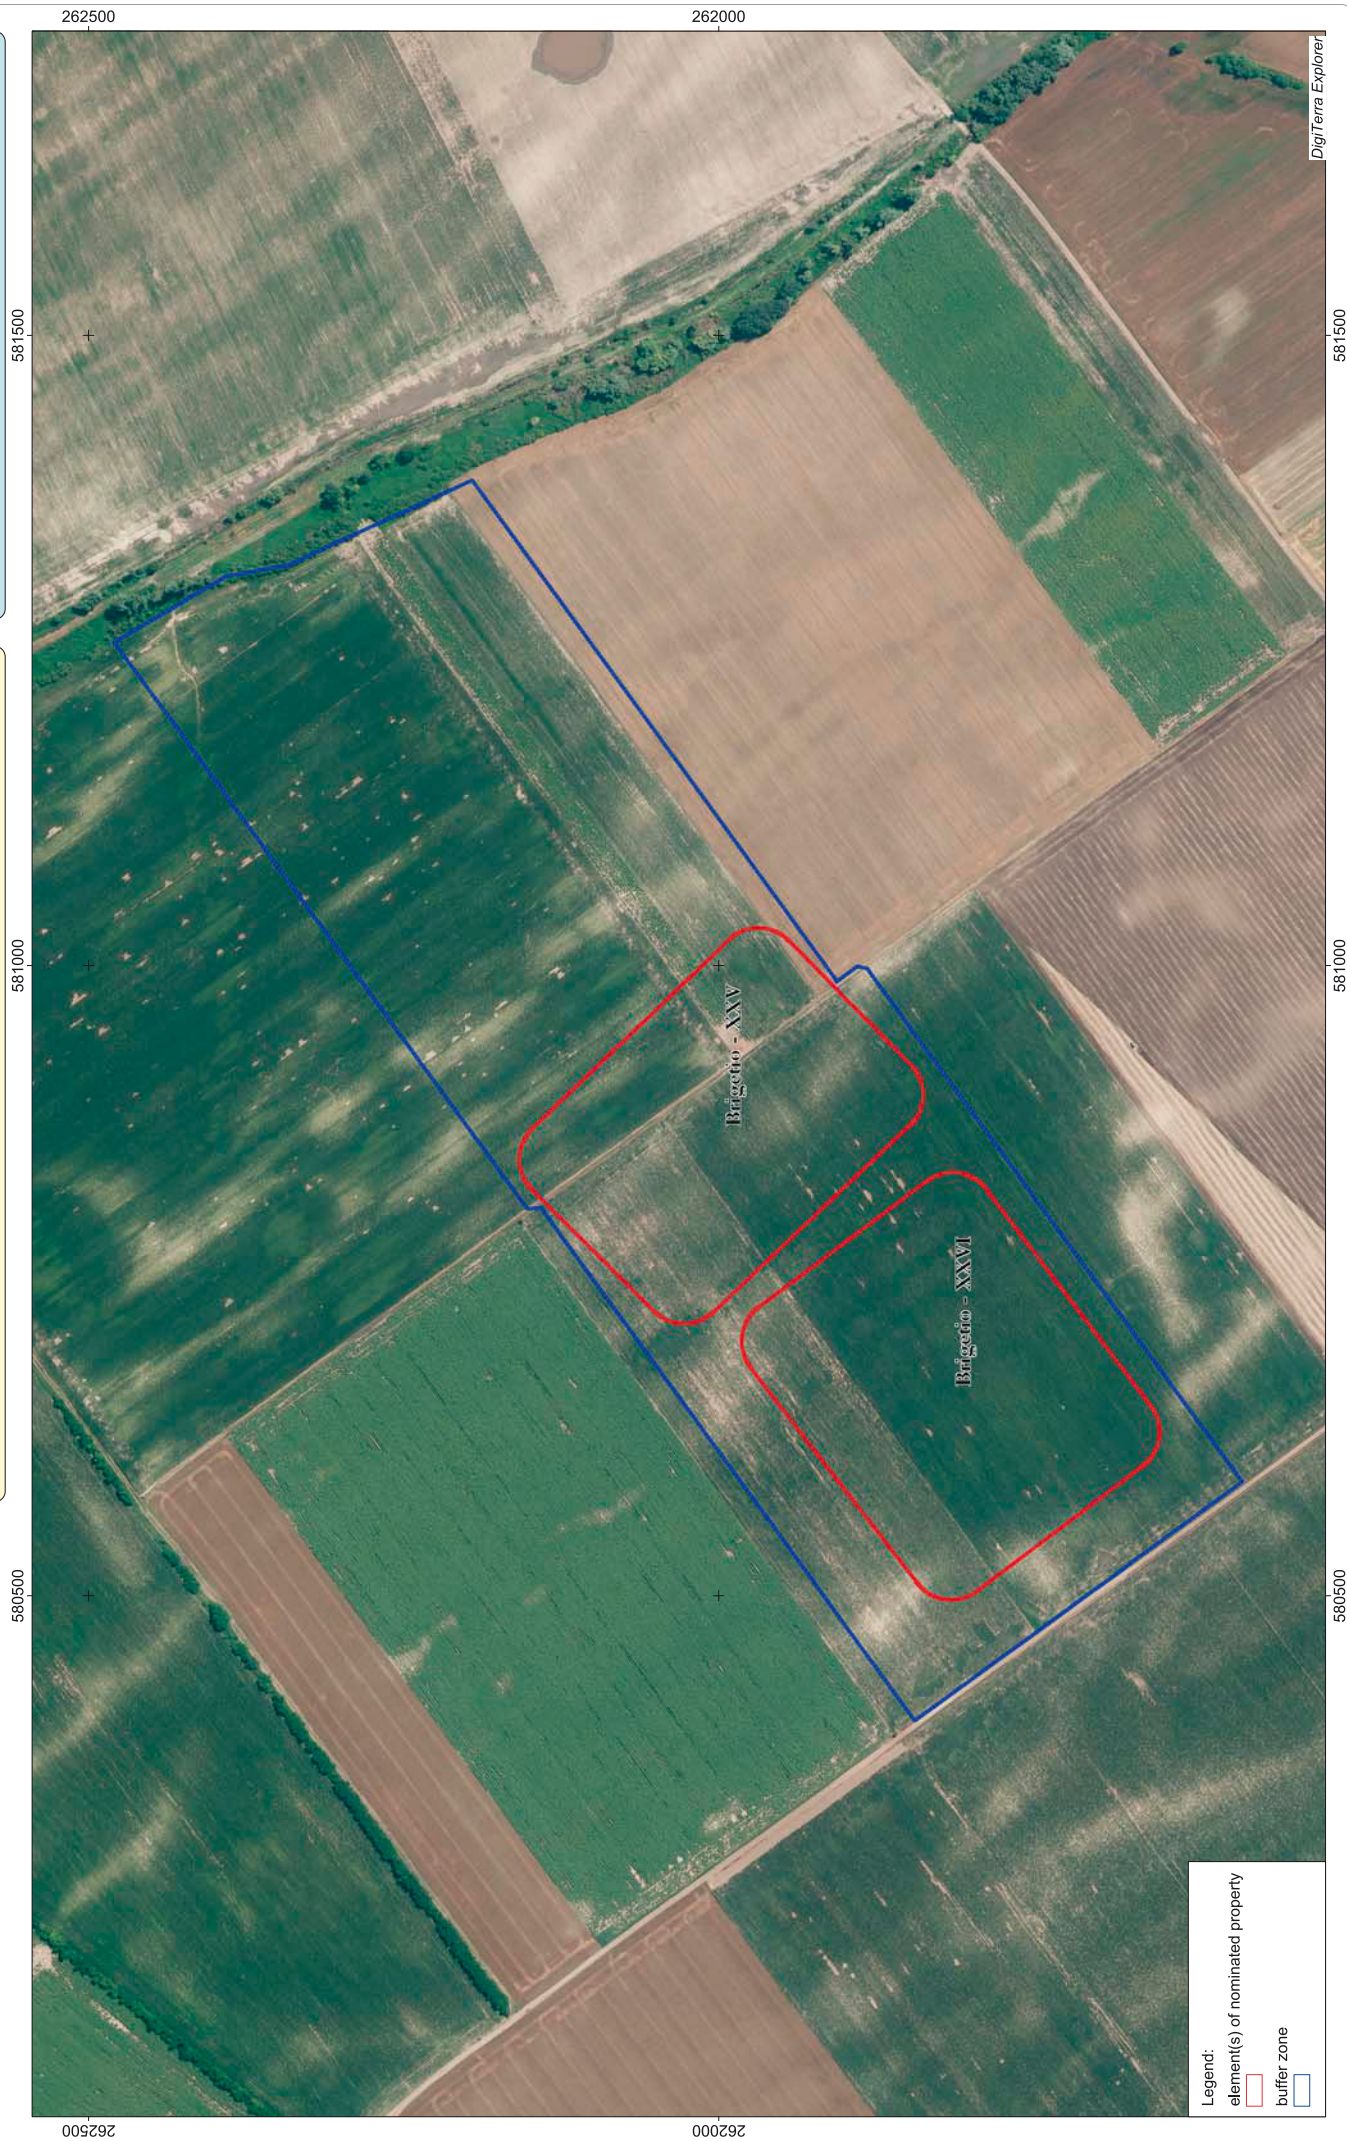
RPH 94. Brigetio – XXV–XXVI camps,
Mocsa

Ground plan of Brigetio – XXV camp (Digitalization: PTE)
